HO 53/1-AB  
23rd August 2000

Forestry Tasmania  
79 Melville St  
HOBART TAS 7000

**R PRELIMINARY GEOTECHNICAL ASSESSMENT  
E: PROPOSED INTEGRATED FOREST PRODUCTS YARD  
HUON DISTRICT**

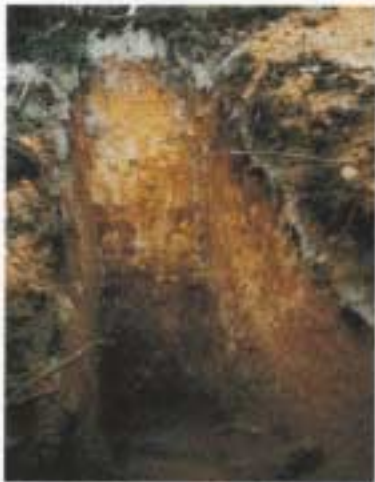
Test Pit 3

Unit 4 is variable in composition but is considered to represent Pleistocene age glacio-fluvial gravels. An attempt was made at test pit 3 to assess the depth of this layer but the unit continued beyond the limit of the excavator reach at about

4.8m below ground surface. The unit comprises medium dense to dense gravel and very stiff gravelly clays. The estimated allowable bearing capacity is 200kPa. Depending on the composition, the gravelly portions of the unit are expected to be suitable as sub-base gravel whereas the clayey portions should be suitable as a selected fill. Long term unsupported cut and fill batters in this material should be constructed at 1.5:1 (H:V) or flatter. Some of the access road fills have been constructed from this unit at 1:1 batter slopes and are showing evidence of erosion. In other places, tension cracks have developed in the shoulder and shallow slumps and landslides can be expected in some fill batters between test pit locations 5 and 6 approximately. The tension cracks are likely to have been caused by settlement due to inadequate compaction at the edge of the fill.
